TRANSPORTATION RESEARCH CENTER

ON-SITE AIR BAG FIRE INVESTIGATION

CASE NO. - 94-16
FLEET - PRIVATE VEHICLE
LOCATION - S [REDACTED], WISCONSIN
ACCIDENT DATE - [REDACTED] 1994

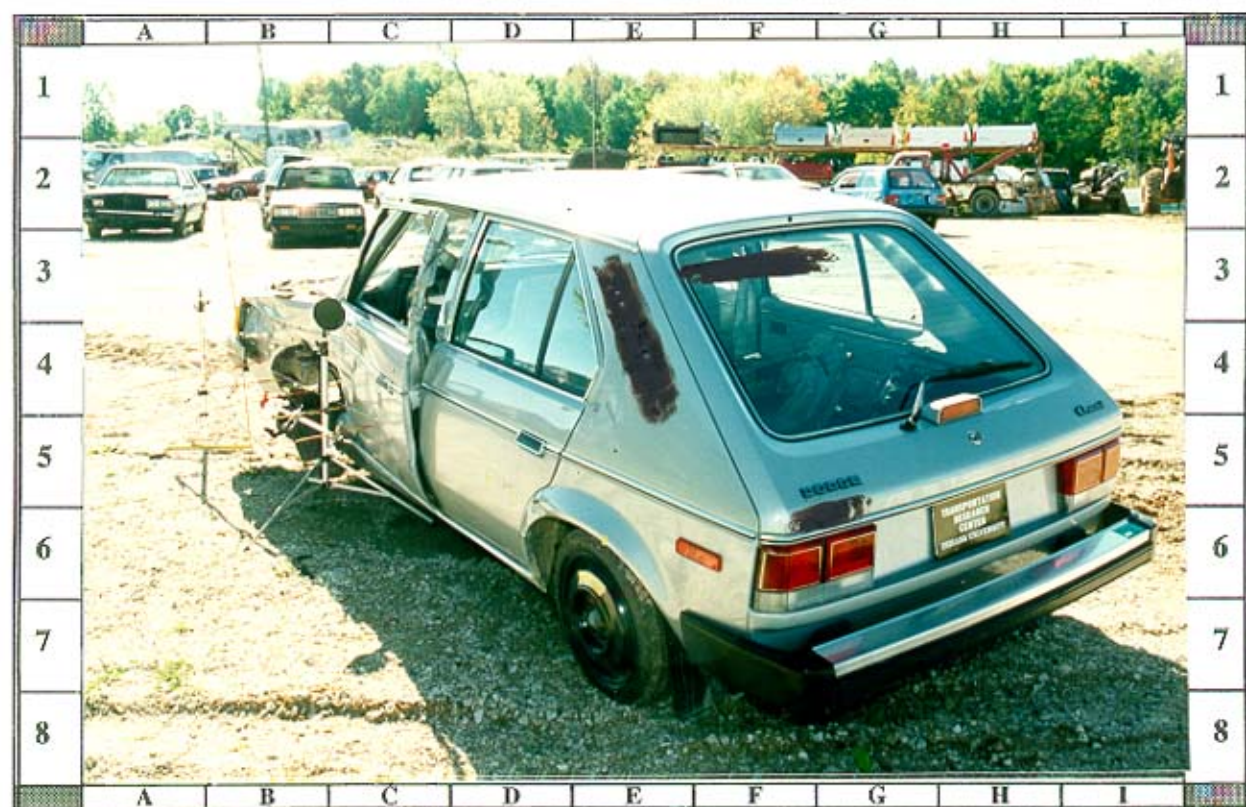
61 -- Close-up of 1986 Dodge Omni's sideslap damage viewed from left rear; NOTE: scuff (cells F2--G2) from Neon's R rearview mirror

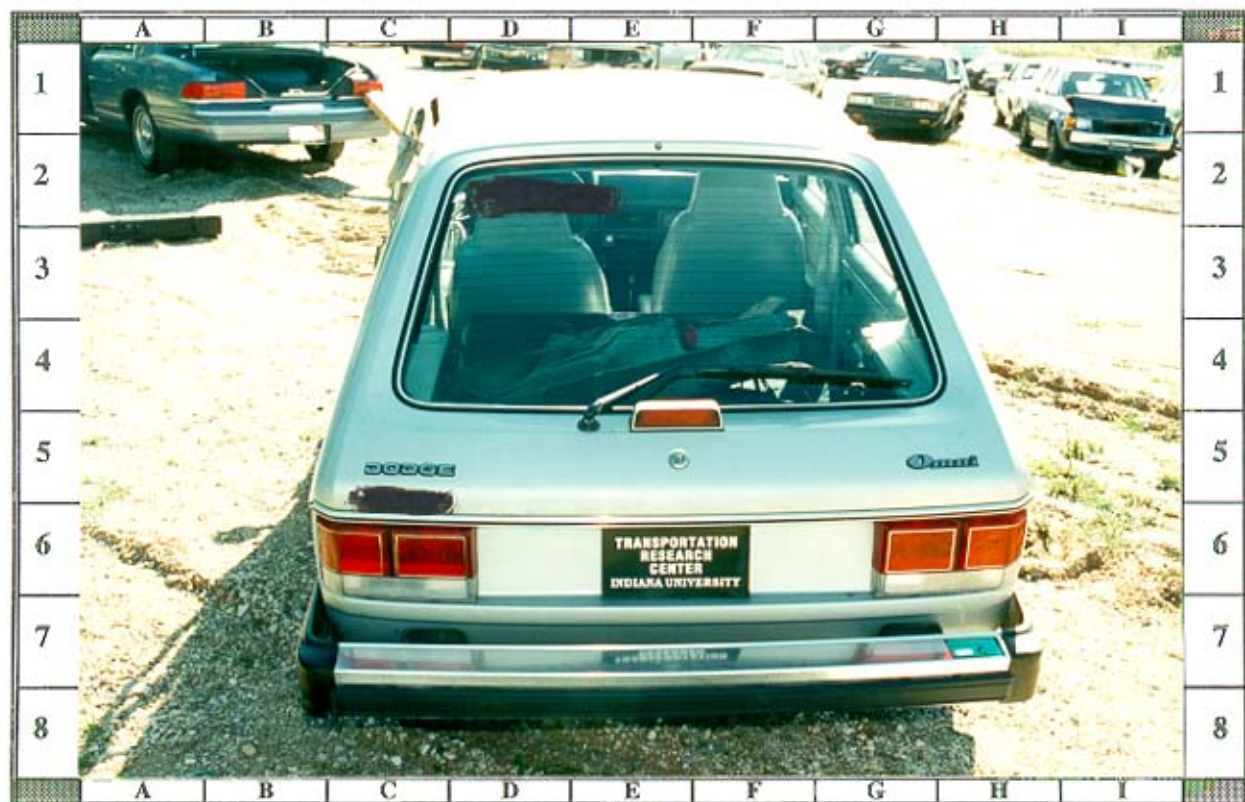
62 -- 1986 Dodge Omni's damaged left side & undamaged rear viewed from rear left; NOTE: rear tires replaced with temporary spare tires

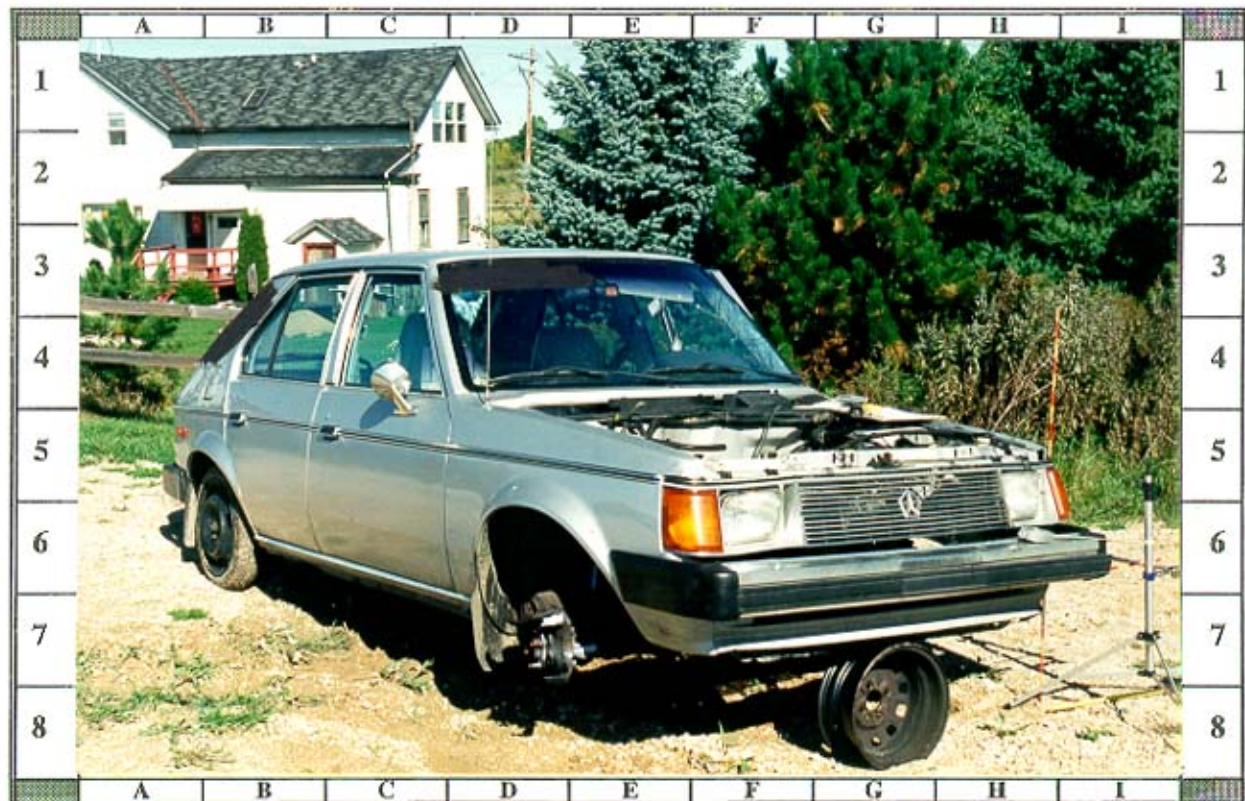
64 -- 1986 Dodge Omni's undamaged front and right side viewed from front right; NOTE: RF tire, hood, & engine have been removed

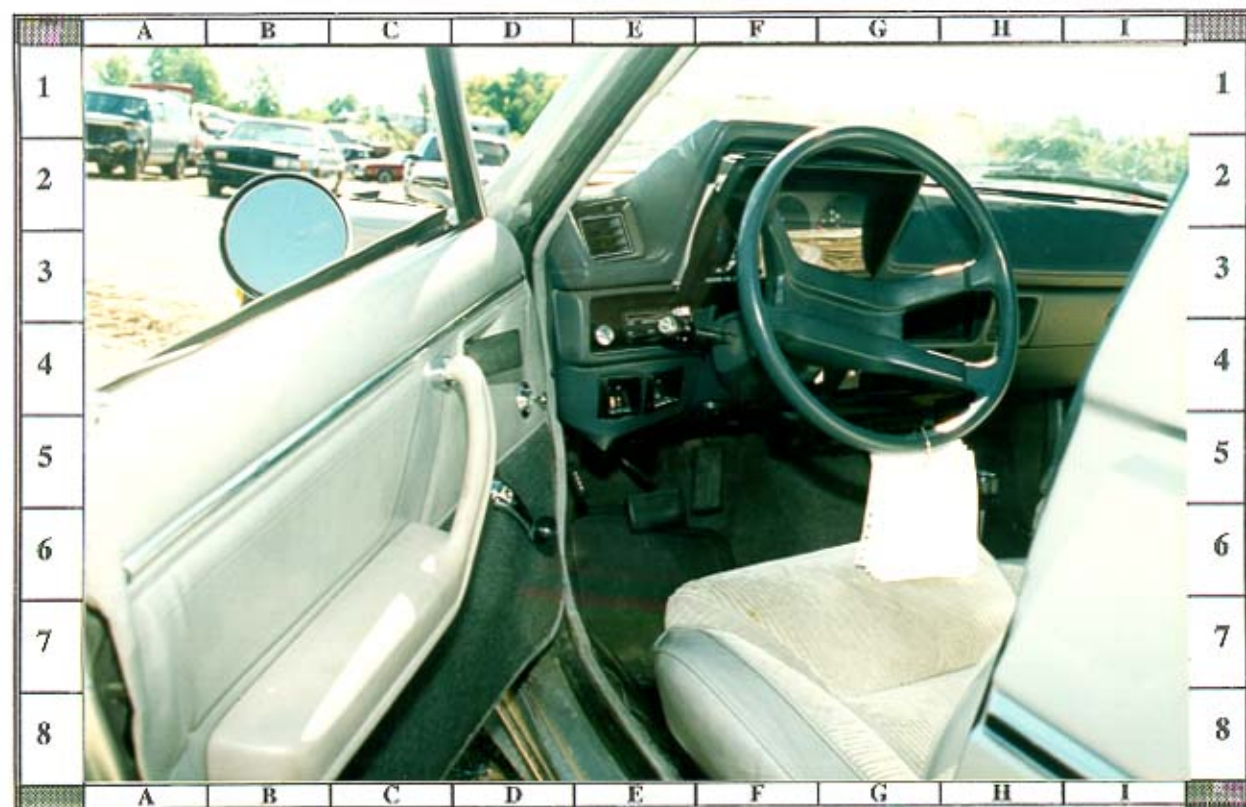
66 -- 1986 Dodge Omni's left front interior door surface and driver seating area; NOTE: no evidence of driver contact

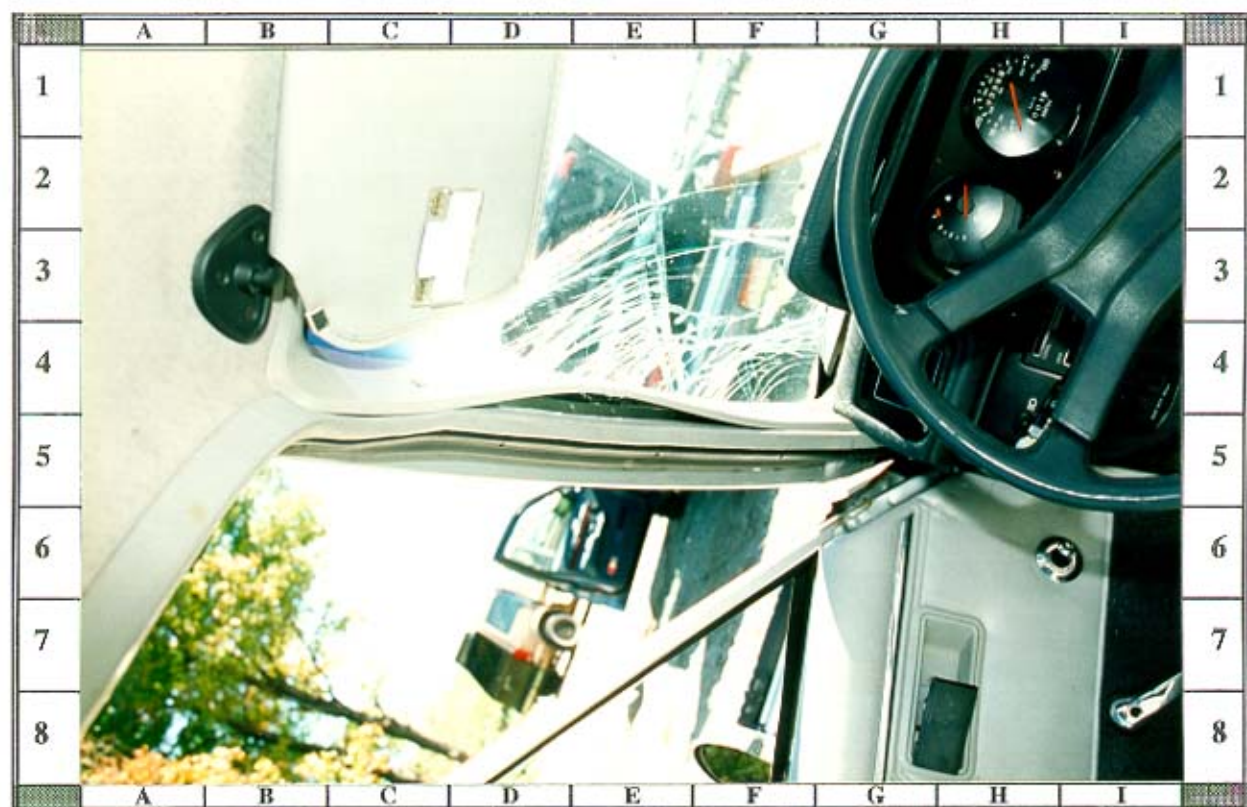
69 -- Close-up of 1986 Dodge Omni's left kickpanel & door sill damaged by intrusion--viewed from right front seating area

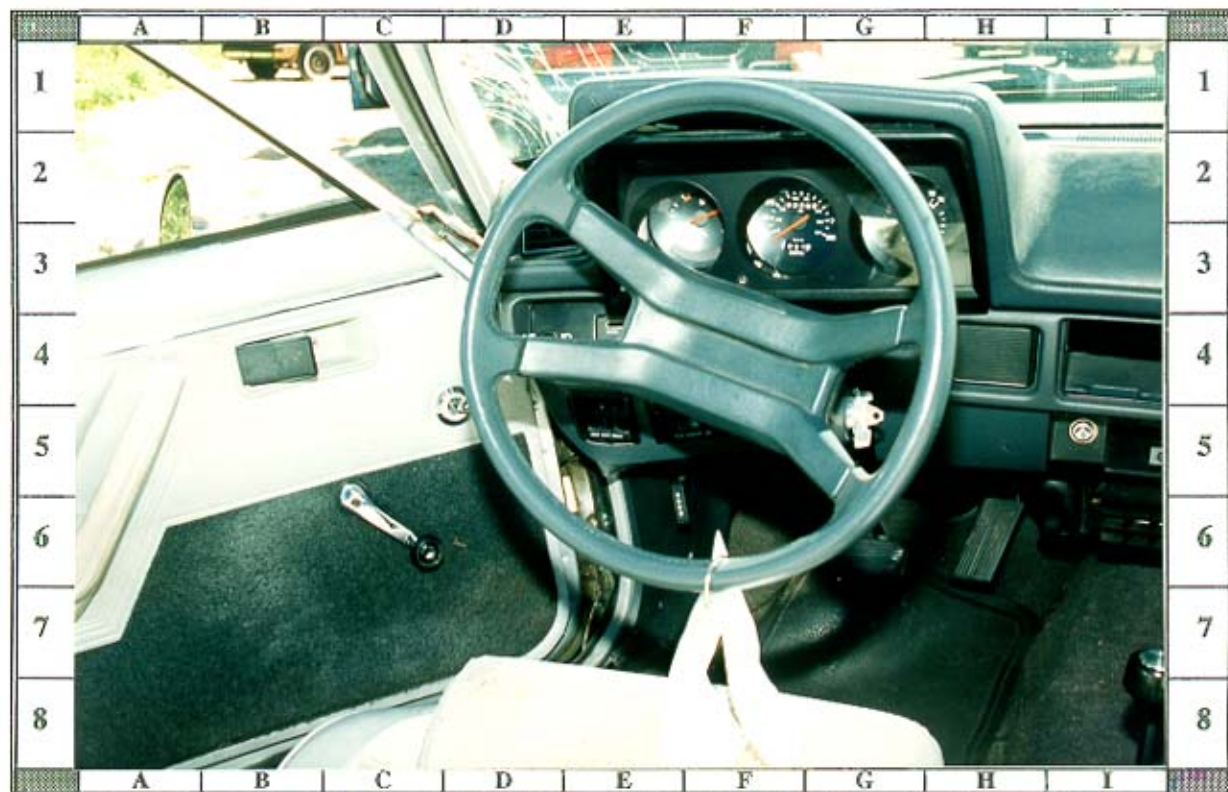
73 -- 1986 Dodge Omni's steering wheel, left interior door surface, and dash viewed from rear center; NOTE: no contact evidence

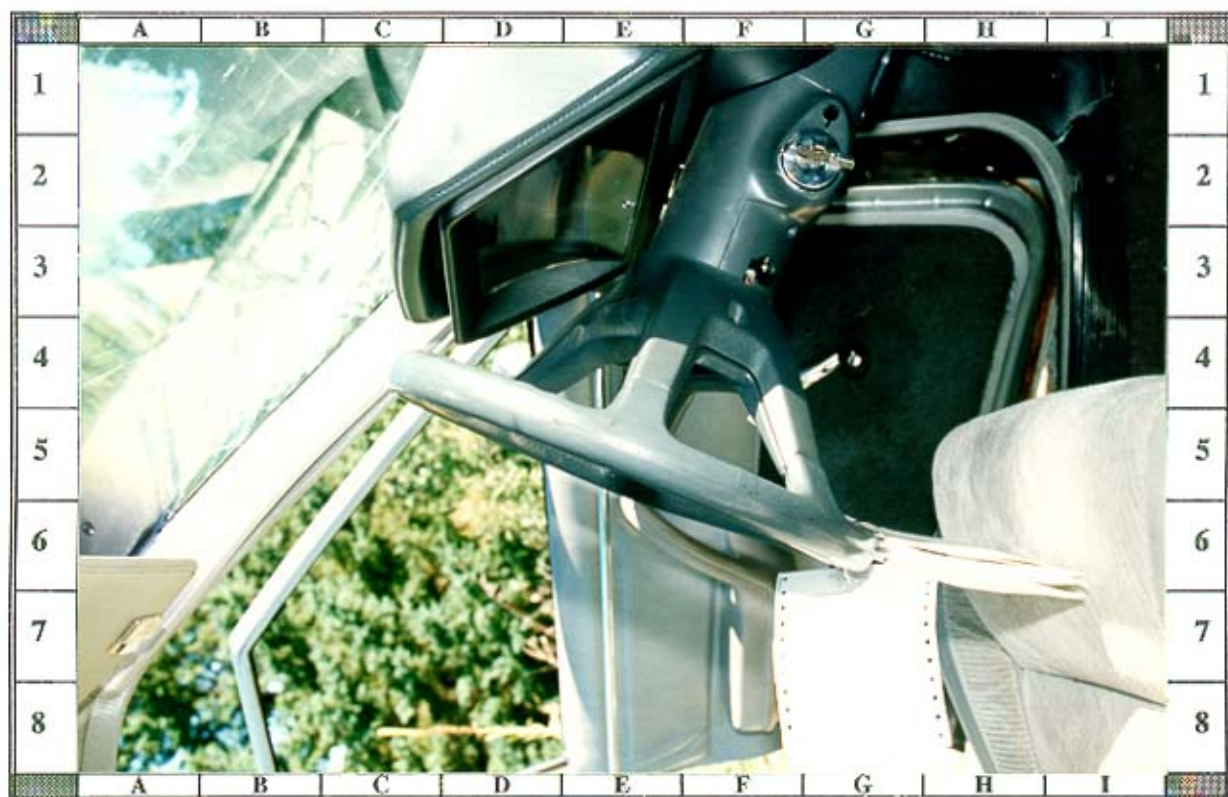
74 -- 1986 Dodge Omni's undeformed steering wheel viewed from right front seating area

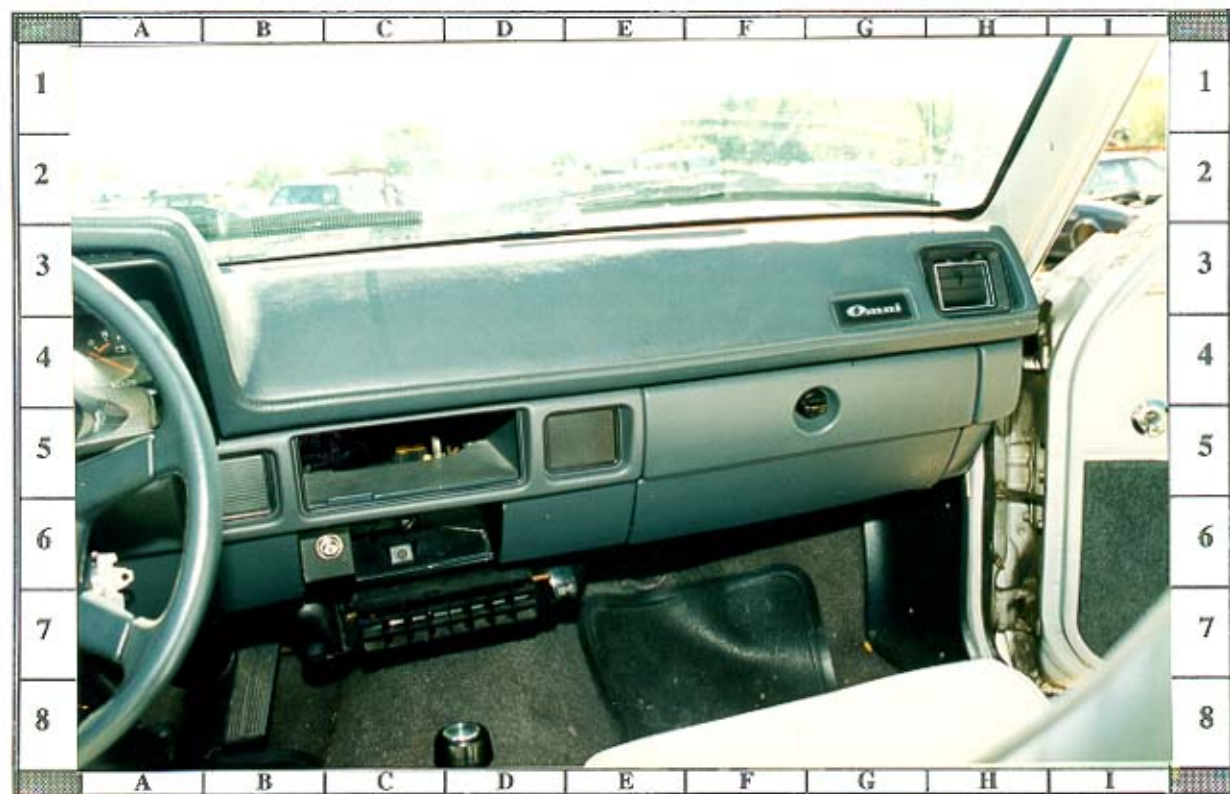
75 -- 1986 Dodge Omni's undamaged center and right dash, toepan, and windshield, and lower right A-pillar viewed from rear center

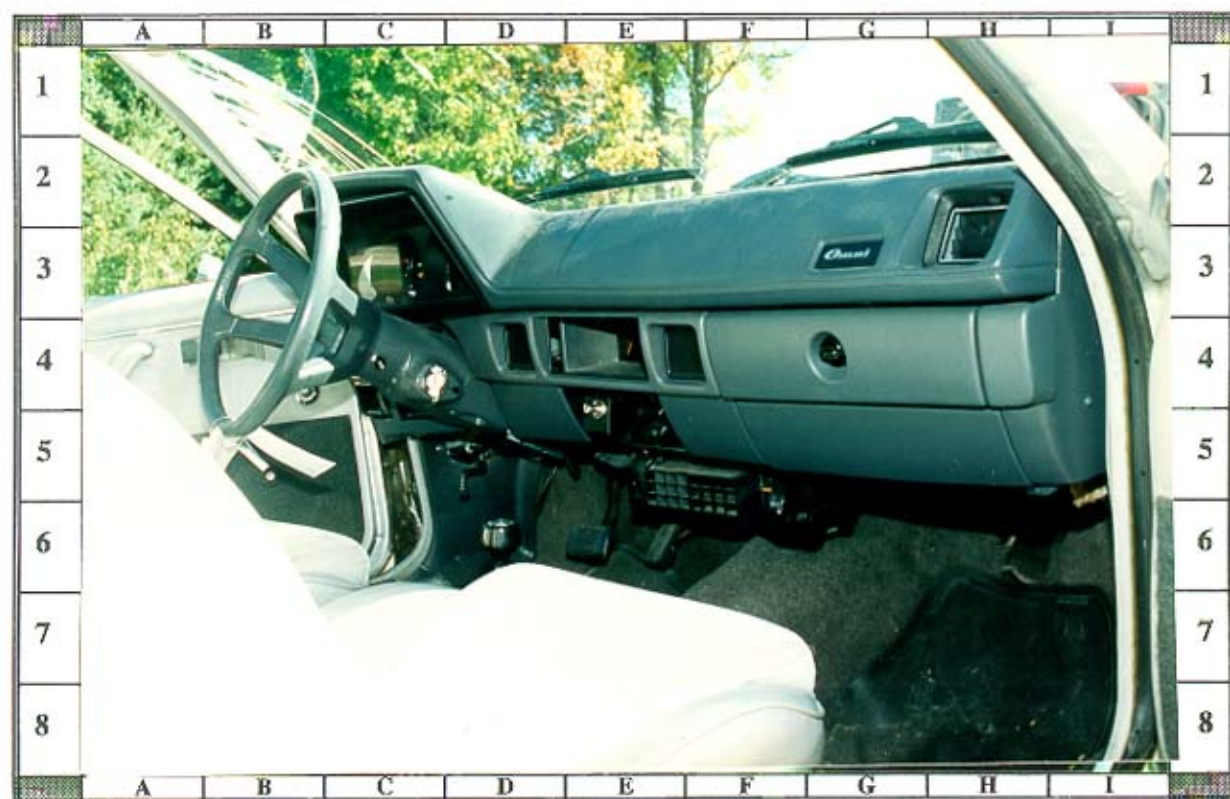
76 -- 1986 Dodge Omni's undamaged dash & steering assembly viewed from right front door; NOTE: radio has been removed

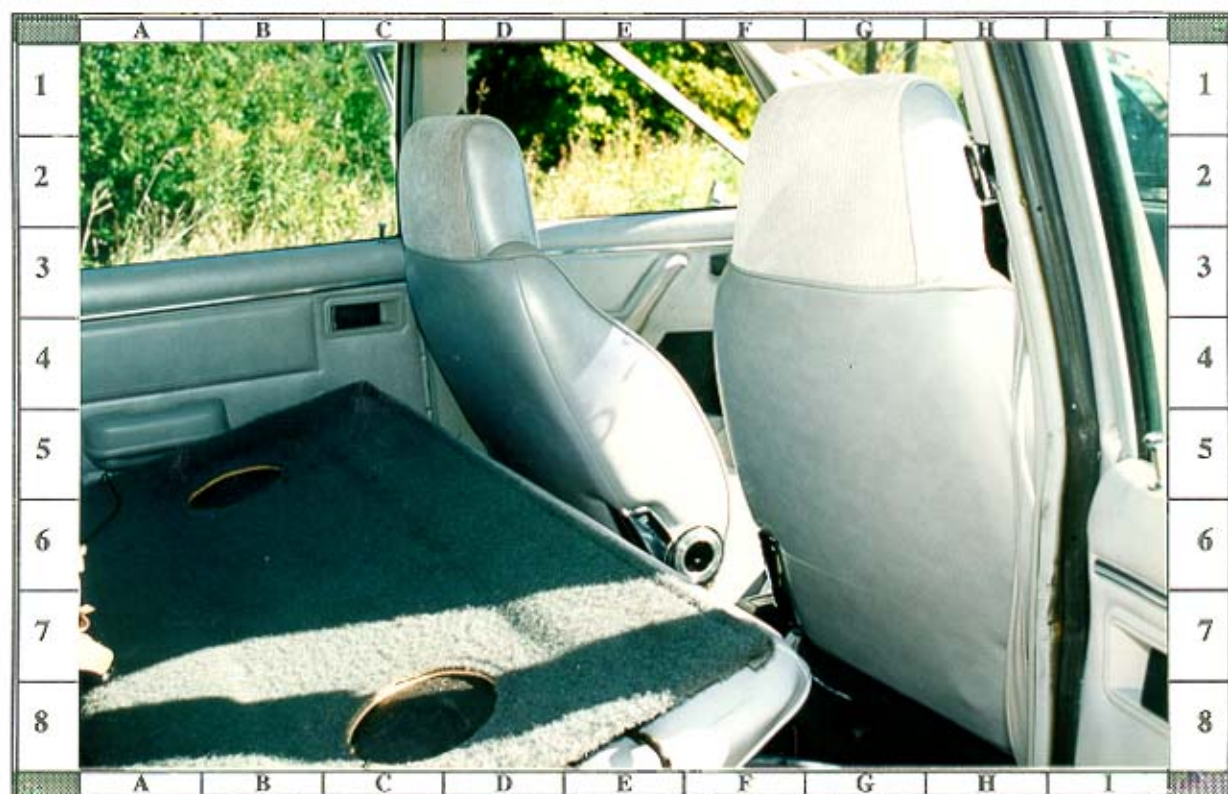
77 -- 1986 Dodge Omni's front seatbacks viewed from right rear door area; NOTE: rear seat back was folded down

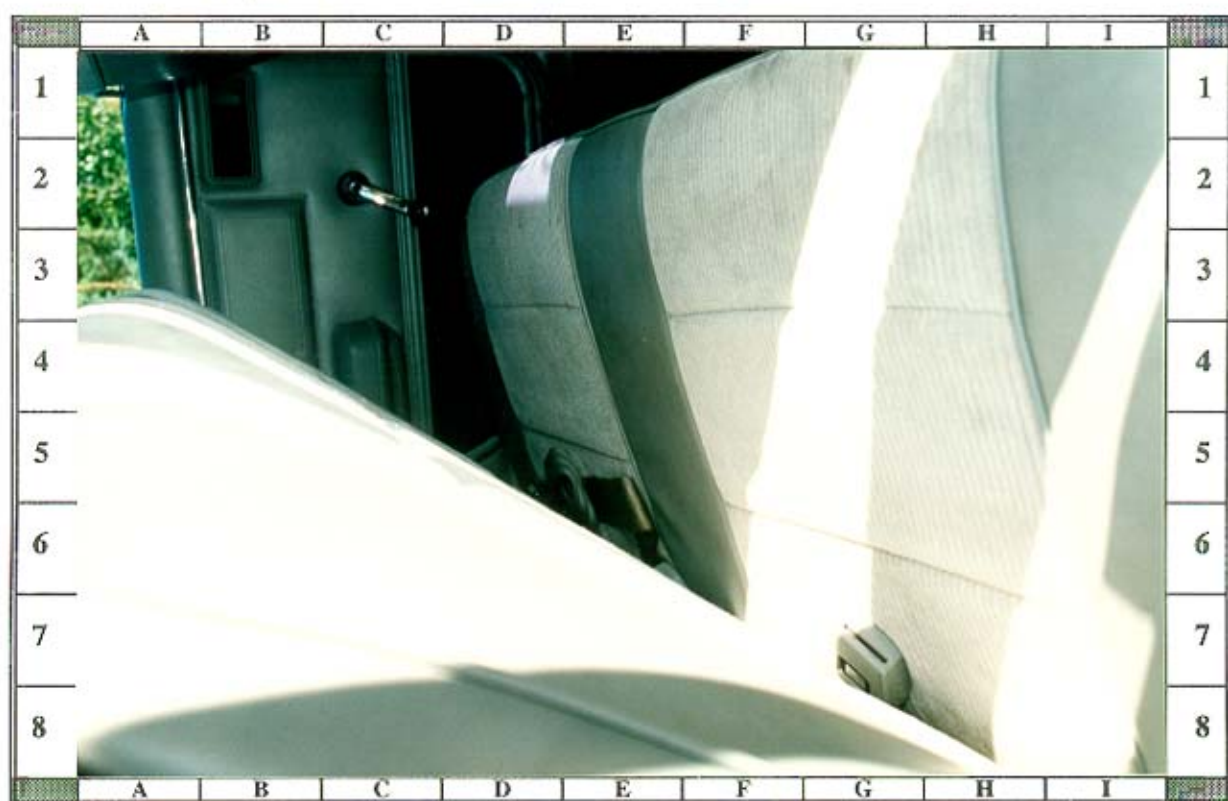
78 -- 1986 Dodge Omni's rear active restraints underneath folded down rear seatback
